## **Magnetic Flux Leakage (MFL)**

### **Non-destructive Detection of Fractures and Cracks at the Reinforcement of Prestressed Concrete Structures**

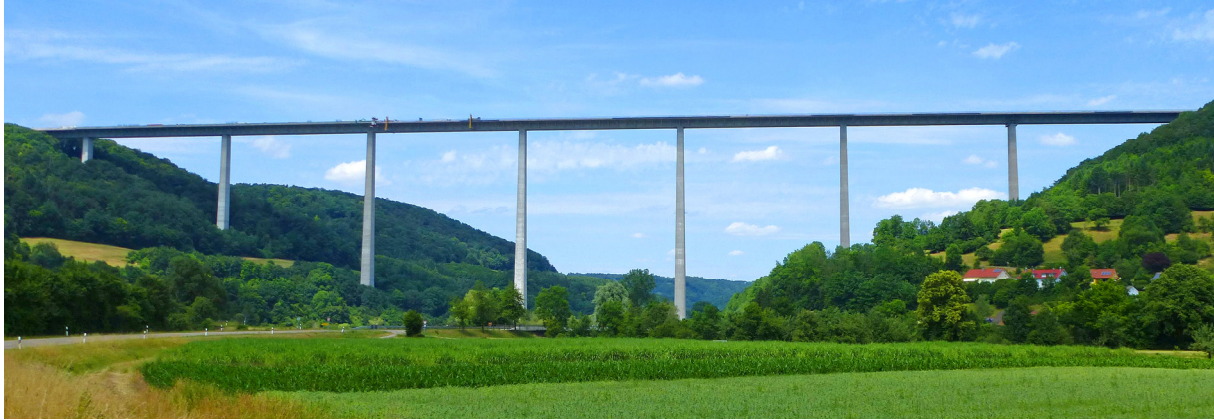
**Figure 1: Use of magnetic stray field measurement on the Kochertal Bridge BAB A 6.**

Around 30 bridge structures have been examined with the REM 350 in the past eleven years e.g. the Kochertalbrücke, the Schüpfbachthalbrücke, the Taubertalbrücke and the Sunshine Skyway Bridge (USA / Florida), as well as 3 parking garages. The result of the evaluated measurement data reflects the actual condition of the cross-tendons and enables the client to realistically assess the load reserves and the reliability of his structure.

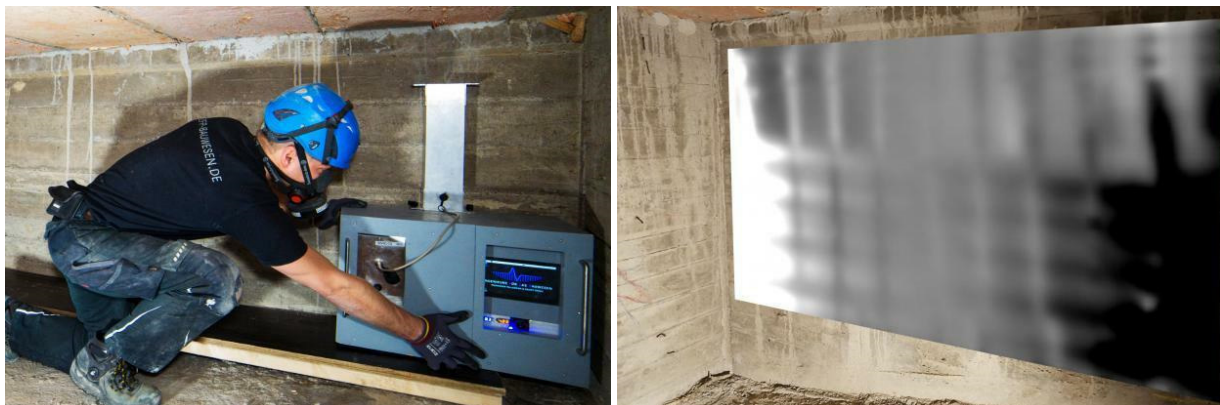
Our GreyOne - Sensor Unit has been developed for the investigation of prestressed box girders (bridge structures, ceiling constructions). The usually limited accessibility and low working height in the box girder structures require maximum flexibility to the measurement technology and the measurement team. This sensor unit allows the inspection of tendons in vertical and horizontal structures. The sensor width can be individually adjusted from 0.40 m to 1.50 m.

**Figure 3: Measurement with the GreyOne - Sensor Unit (left), magnetic image of longitudinal tendons (right)**

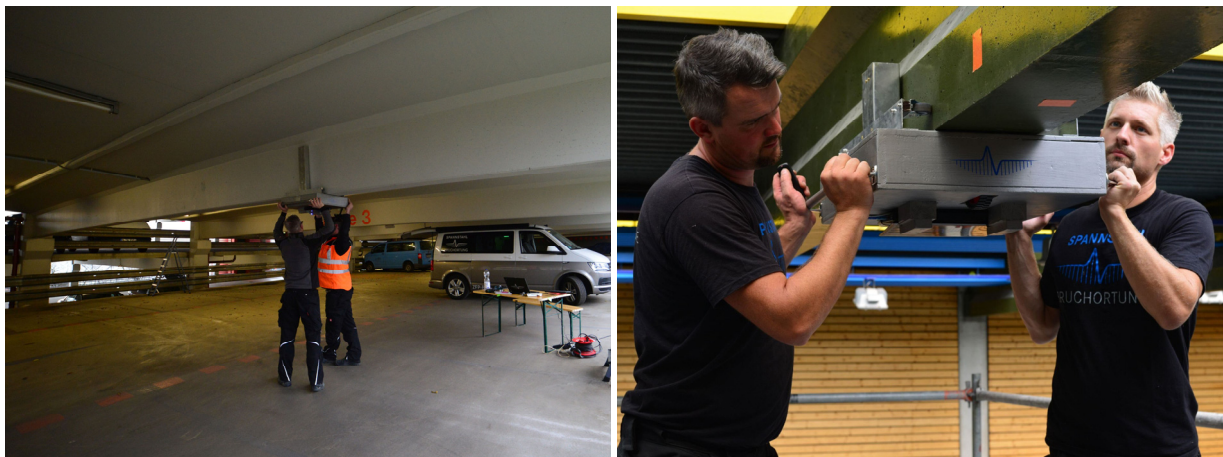
The U - Sensor Unit has been specially developed for the investigation of prestressed beam cross-sections. The arrangement of the magnetic sensors enables the simultaneous measurement of the magnetic stray field from all three beam sides (both web sides and the bottom flange) with only one traverse of the component to be examined. Depending on the cross-section of the component, the U-sensor unit is adapted to the geometry of the girder sides (individual adaptation to the web height and belt width of the girders). Thus, almost all prestressed concrete girders can be inspected quickly, efficiently and non-destructively for fractures in the tendons / prestressing wires.

Figure 4: Investigation of prestressed concrete beams with the U - Sensor Unit

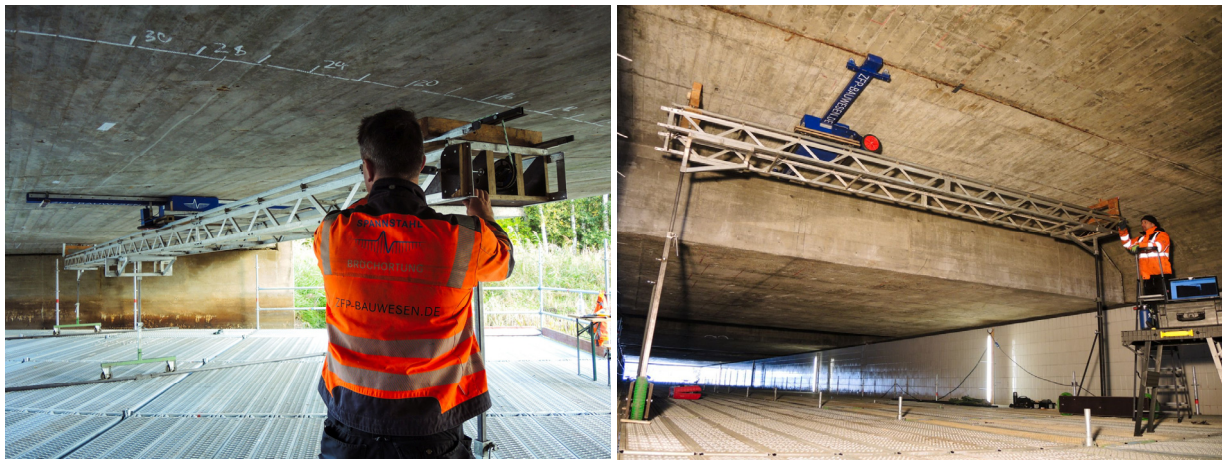
The BlueOne is a further developed 1.50 m to 3.0 m wide sensor unit (cf. REM 350), which wirelessly measures the magnetic stray field of the area to be examined and generates two-dimensional black-and-white scaled magnetic images from the measurement data. By displaying the measurement results (sensor width x measurement length) in an area image, the reinforcement situation in this entire area can be visually interpreted and evaluated accordingly.

Figure 5: Investigation of prestressed bridge surfaces with the BlueOne – Sensor Unit

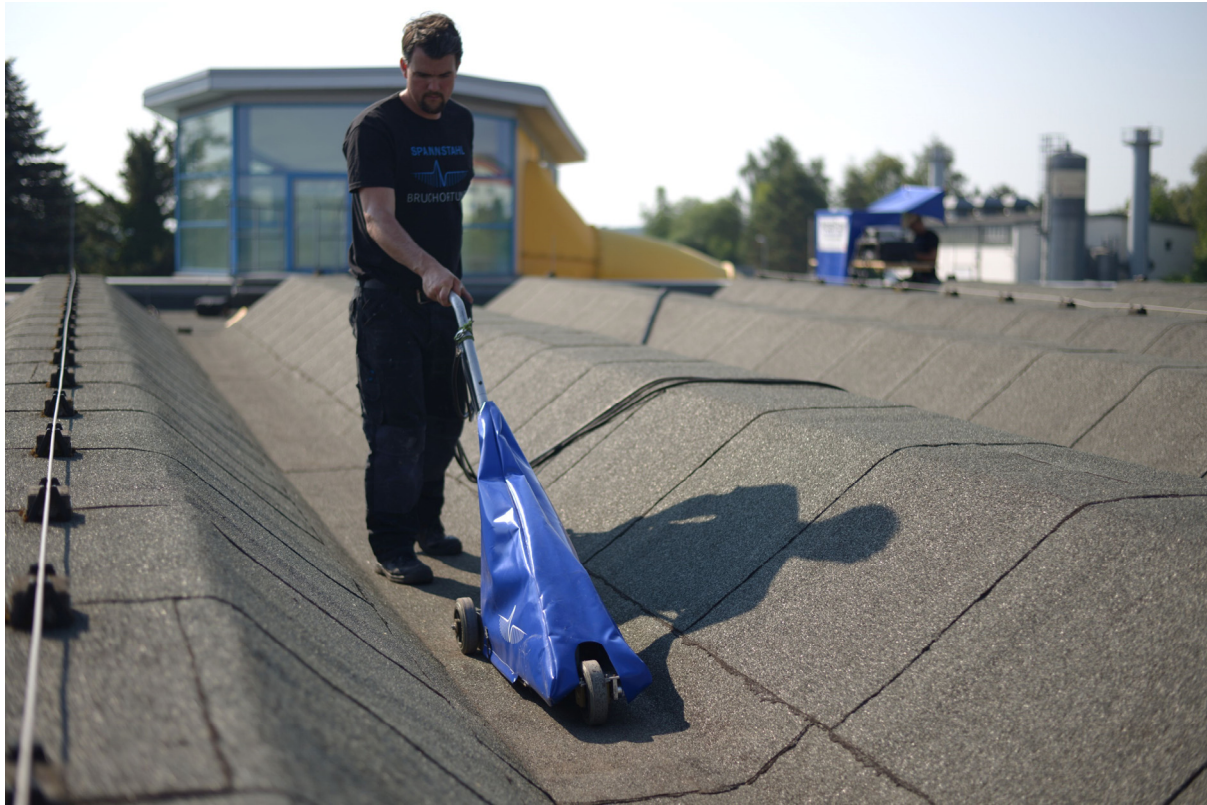
Mobile guide system for straight tendons that lie on the top of the component, e.g. for floor slabs of parking decks or roof structures of sports halls (e.g. VT folds).

**Figure 6: Examination of VT folds in a swimming pool.**

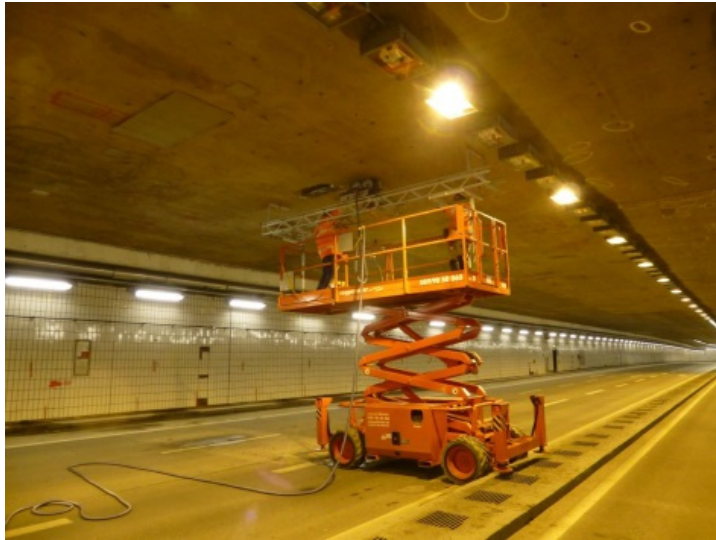
**Figure 7: Examination of a tunnel ceiling.**

Lattice girder rail system with lengths of up to 18 m with straight tendons in bridge girders and roof or ceiling trusses. The lattice girder rail system can be used both standing and hanging and its height can be adjusted. This means that both the tendons in the underside and the laterally in the lower flange can be examined (example images on the following page).

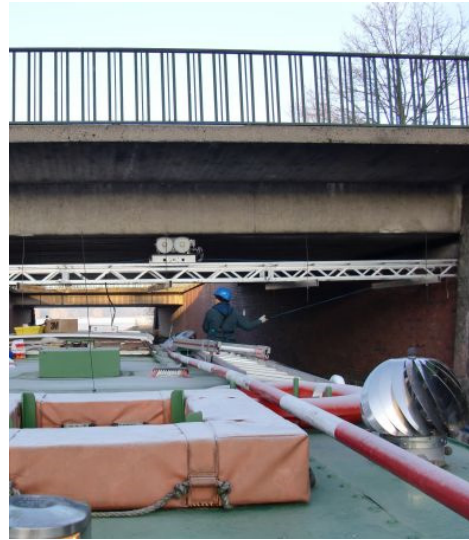
**Figure 8: Examination of bridge girders.**

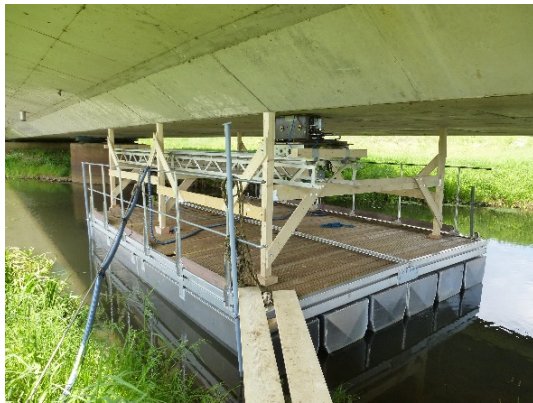
**Figure 9: Examination of a prestressed concrete bridge with the help of a floating platform.**

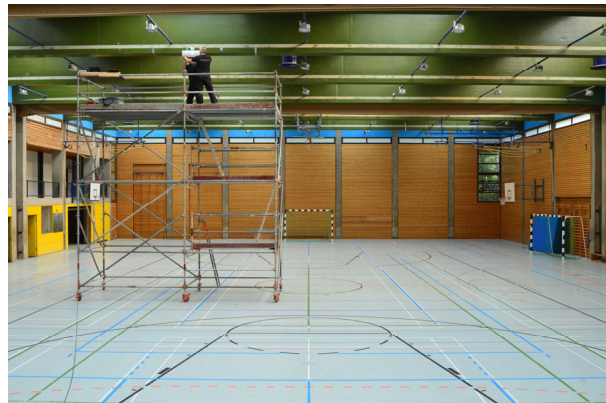
**Figure 10: Examination of prestressed concrete girders in a sports hall.**

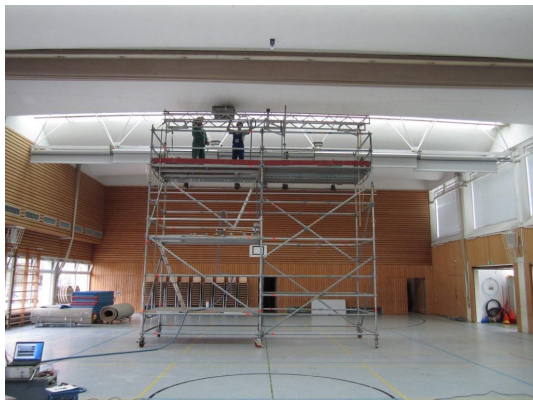
**Figure 11: Examination of double-curved hyperbolic shells (HP shells).**

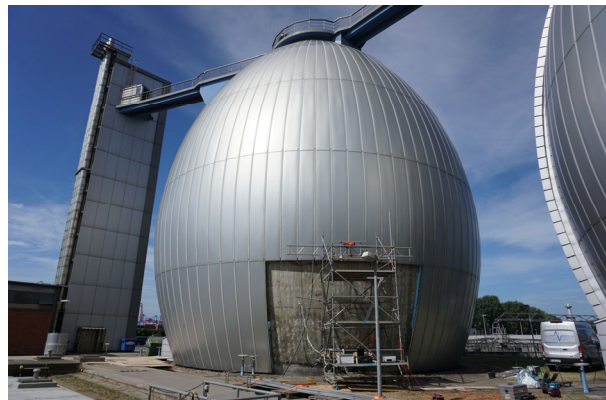
**Figure 12: Examination of tendons of a digester.**

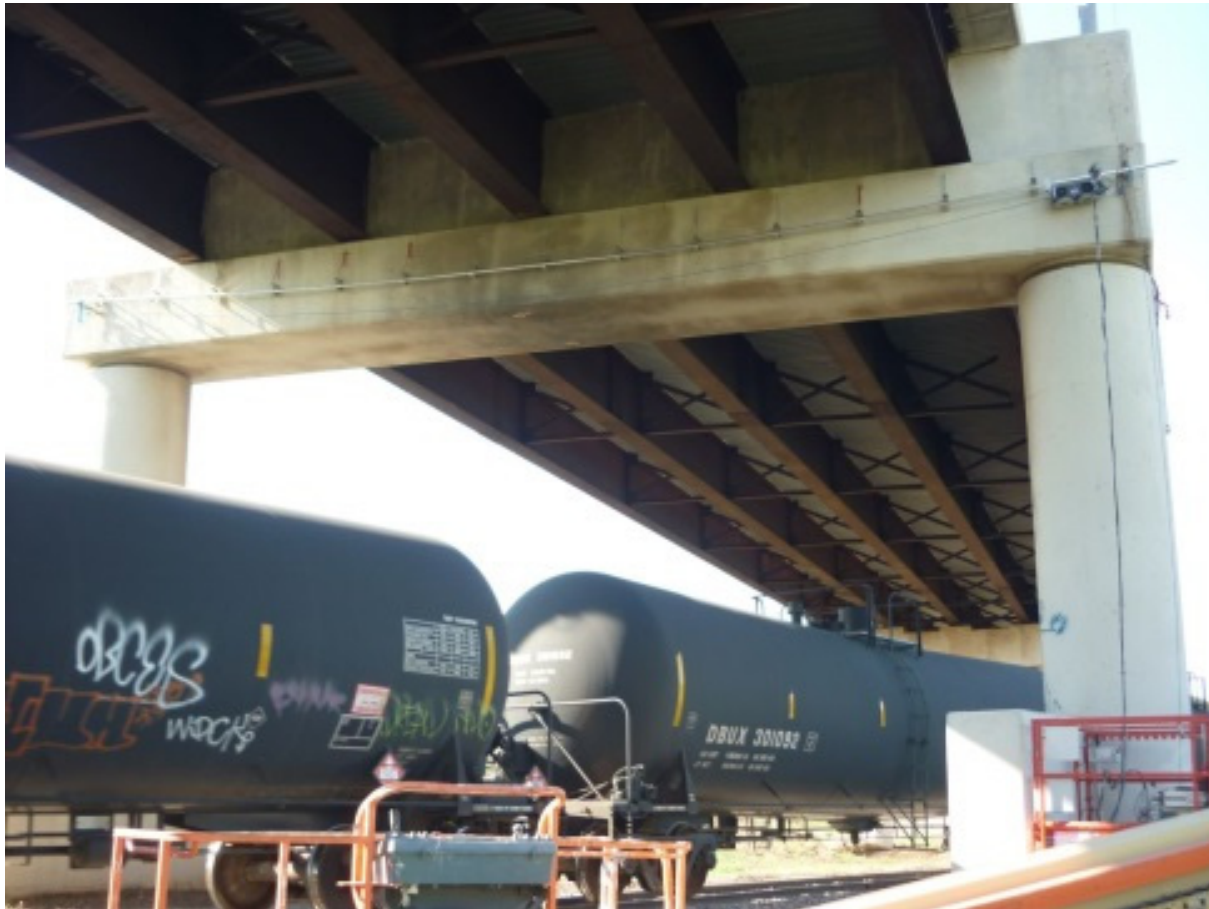
Hanging pipe system with lengths up to 18 m with parabolic tendons e.g. Bridge girders or hollow box girders. The pipe system can be individually adapted to the tendon profile by means of holes in the beam itself or in the structure above.

Figure 13: Examination of bridge girders with parabolic tendons.

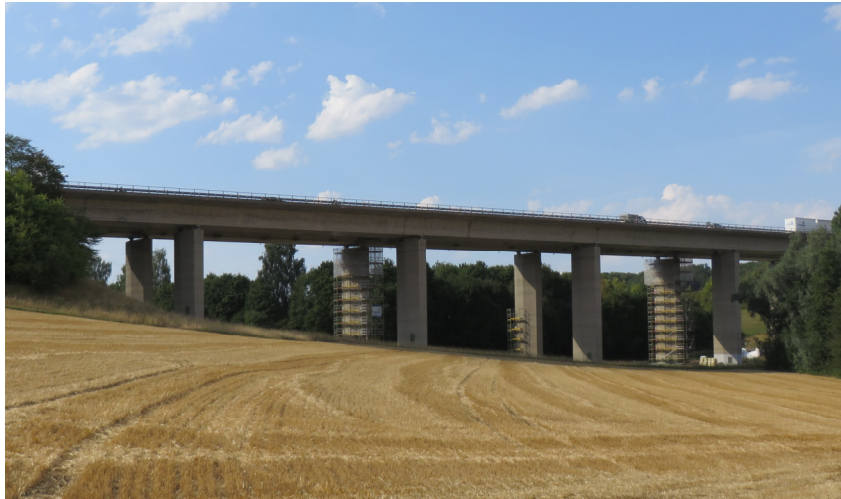
**Figure 16: Prestressed concrete highway bridges. The transverse tendons in the bridge slab were examined, which are highly susceptible to corrosion through the use of de-icing salts (a: Schüpfbach Valley Bridge BAB A 81, b: Sunshine Skyway Bridge Florida / USA).**

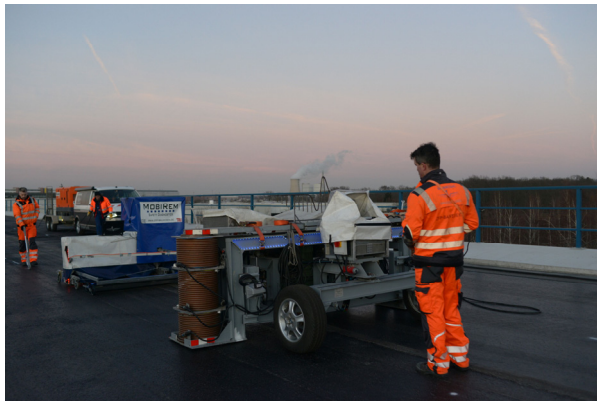
**Figure 17: Examination of the slab of a highway bridge in Wolfsburg.**

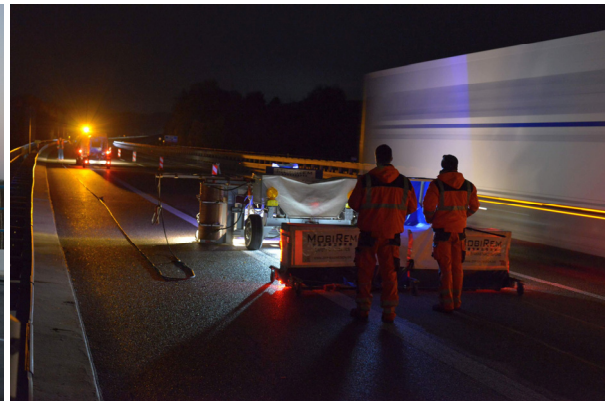
**Figure 18: Examination of the carriageway slab of a highway bridge on the BAB A 81.**
